CAPINTEC, INC.

*******PRODUCT ALERT – CORRECTIVE ACTION*******

CAPTUS 3000 SPRING ARM FAILURE

Captus 3000 and Captus 700 Thyroid Uptake Systems
Shipped between August 1, 2011 and April 30, 2012

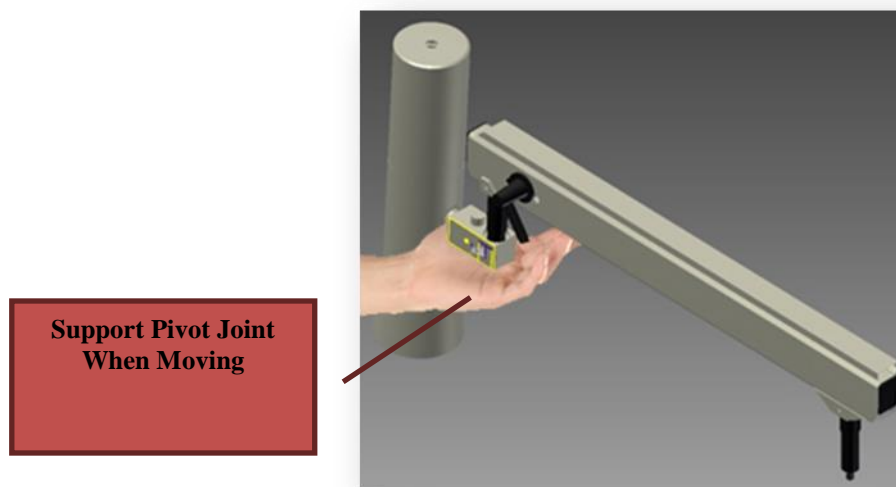
The failures are the result of a broken tension rod (a component inside the arm). A break in the tension rod can cause the collimator to fall downward to its lowest point of travel, which is approximately 25 inches from the ground. The collimator and arm collectively weigh 45 pounds, and there is the potential for injury if the collimator were to come into contact with a patient or operator. In the reported cases, the failure occurred during movement of the arm.

1. Review this Alert and ensure that all affected personnel, including all operators of Captus 3000 and 700 Systems, are aware of the contents.
2. Instruct affected personnel and operators to comply with the following steps in the interest of patient and operator safety:
 - a. Prior to moving the arm, ensure that the positioning locks are released.
 - b. Use caution when moving the arm. **Support** the arm at the collimator pivot point as shown in the photograph below when moving the arm.
